Second Five-Year Review Report for Normandy Park Apartments FLD984229773

Hillsborough County, Florida

September 2011

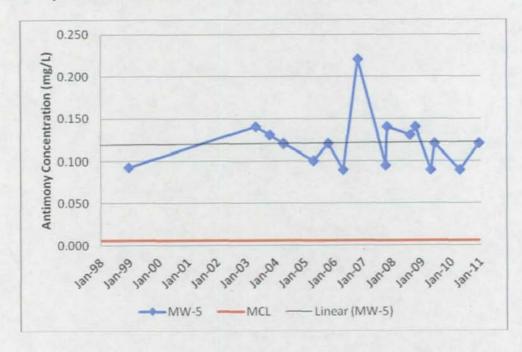
Figure 6: Antimony Concentrations in MW-5

The highest concentrations of antimony were found in MW-5. Concentrations in MW-5 have remained stable around 0.12 mg/L. MW-5is located along the western property boundary in the southwestern corner of the Site (Figure 2). During the October 2011 ground water monitoring event, ground water flow at the Site appears to be to the east and southeast from a ground water "high" located west of the western property boundary. This flow pattern is similar to that reported during prior sampling events.

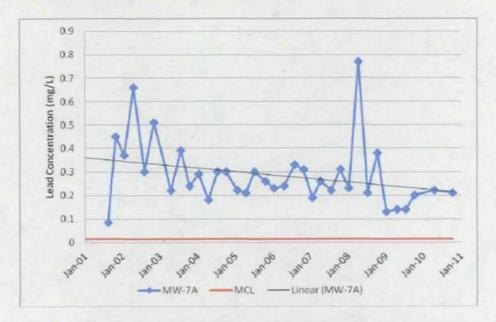
Figure 13: Lead Concentrations in MW-7A

Lead concentrations were below the MCL in all sampling events at eight of the 11 monitoring wells (Table 6, above). Although MW-1 and MW-12 had lead concentrations above the MCL, they have both been at or below the MCL for lead since April and October 2009, respectively. Lead concentrations have been consistently above the MCL in MW-7A, but there is an overall downward trend in the past 10 years (Figure 13). Although there is an overall declining trend in MW-7A, the past three sampling events found lead concentrations greater than the previous three sampling events.

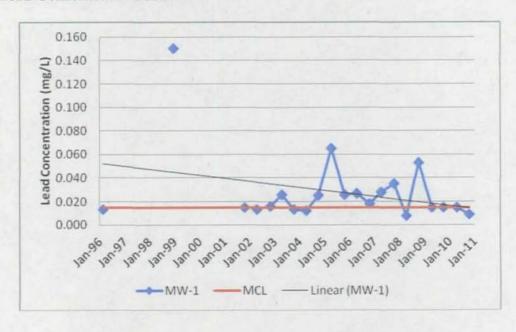
Figure 14: Lead Concentrations in MW-1

MW-1 is the only other well in which the MCL for lead was repeatedly exceeded in the past five years (Table 6, above). Concentrations have declined in the past 10 years and have fluctuated above and below the MCL in recent sampling events (Figure 14). The most recent sample was below the MCL, but concentrations exceeded the MCL in four of the past nine sampling events. The lead MCL was also exceeded during the April 2009 sampling event in MW-12 (Table 6, above). However, the trend in the lead levels indicates that lead levels overall continue to decline.

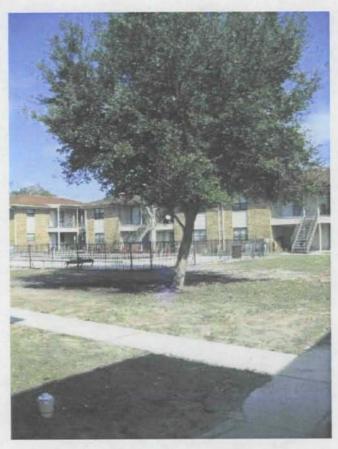
Tennis court cover

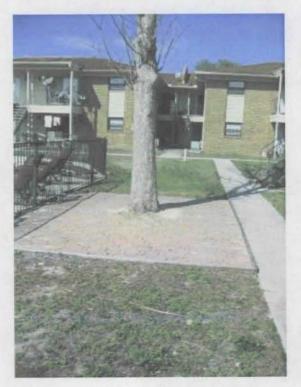
Tree planted since construction of remedy
